Monitoring Federal Lands and Highway Program (FLHP) Revegetation Sites

Russ Haas, Denver Service Center, National Park Service

2011 Mount Rainier Revegetation Monitoring Data

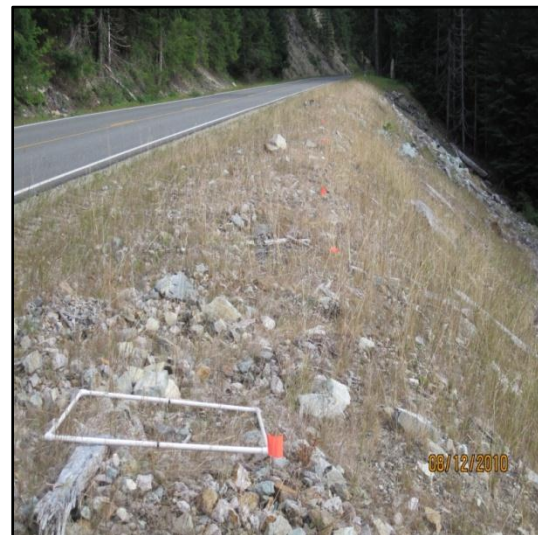
Figure 1. SH123 Buttress #1 monitoring 8/2/10

Buttress #1- Summary of transects 1-6 data: Seeded Native Species percent frequency : *Elymus glaucus* , blue wildrye 77%; *Bromus carinatus*, California brome grass 0%; *Festuca rubra*, red fescue 100%; *Antennaria microphylla* , pearly everlasting 25%; *Abies amabilis*, silver fir 25%

Non- Seeded Native Species percent frequency: *Polygonum bistortoides*, bistort 40%; *Epilobium angustifolium*, fireweed 28%,
Invasive species percent frequency: *Leucanthemum vulgare*, oxeye daisy 19%; *Lotus corniculatus*, birdsfoot trefoil 22%

Bare Ground: 27% **Debris:** 33%
Plant Cover : 12%

Buttress #1 involved placement of large boulders starting at base and proceeding up slope with slightly smaller boulders /rocks mixed in near top. **Topsoil:** 4" of salvaged mineral (very low organics) topsoil placed over the boulders/rocks as far down slope that could be reached with equipment (30ft?) Park personnel state that much of the topsoil that was applied fell into the voids caused by the spacing of the large boulders leaving little topsoil for plant growth near bottom of slope. Coverage improved as proceed up slope where the boulders/rocks were somewhat smaller to retain topsoil. As expected establishment , performance and survival of species reacted according to the amount of topsoil remaining.

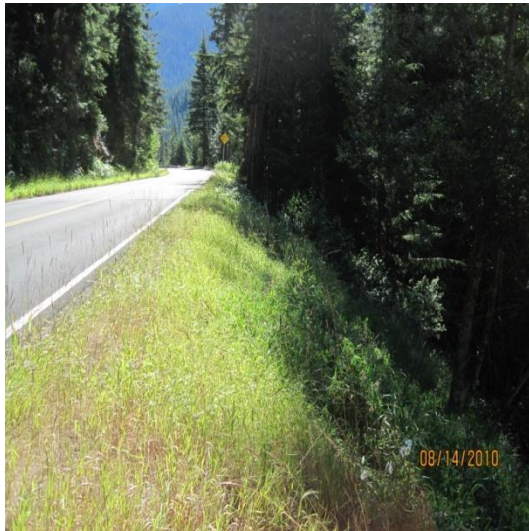
Figure 2. SH123 ERFO Wash out #2

Wash out #2- Summary of transects 1-4:
Seeded Native Species percent frequency: *Elymus glaucus*, blue wildrye 100%; *Bromus carinatus*, California brome grass 16%; *Festuca rubra*, red fescue 22%; *Epilobium angustifolium* , fireweed 24%; *Antennaria microphylla* , pearly everlasting 17%; *Abies amabilis*, silver fir 31%,

Non seeded native species percent frequency : *Carex sp*, sedge sp. 33*%;
Rubus parviflorus, thimbleberry 17%*;
Oplopanax horridus, devils club 17%*;
Adenocaulon bicolor , pathfinder 17%*

Invasive species: percent frequency
Potentia sp. 33%; *Trifolium repens*, white clover 17%*

Plant Cover : 23% **Bare Ground:** 33% *
Debris: 36% **Large Rock:** 28% **Large Log:** 19%

Wash outs #2 & 5. Experience from working with the buttresses the previous year was used to repair and revegetate damaged areas. Rock and boulder placement included smaller materials to fill voids left by large boulders the entire length of slope. Six inches of manufactured topsoil, composed of 40%OM 60% mineral (see project write up for components) compared to 20% OM 80% mineral on buttresses #4, was placed the entire length of slope with a better type of equipment which allowed soil placement 60 feet down slope and the bulk seeded rate was increased to 24 lbs per acre. These modifications of methods resulted in much improved plant establishment and coverage even though the slope is 70% compared to 50% for the buttresses..
